Causal Analysis Report

Chevron Richmond Refinery
Reportable Flaring Events

November 3-8, 2020

Flaring Due to Hydrogen Plant Start-up Following Power Outage

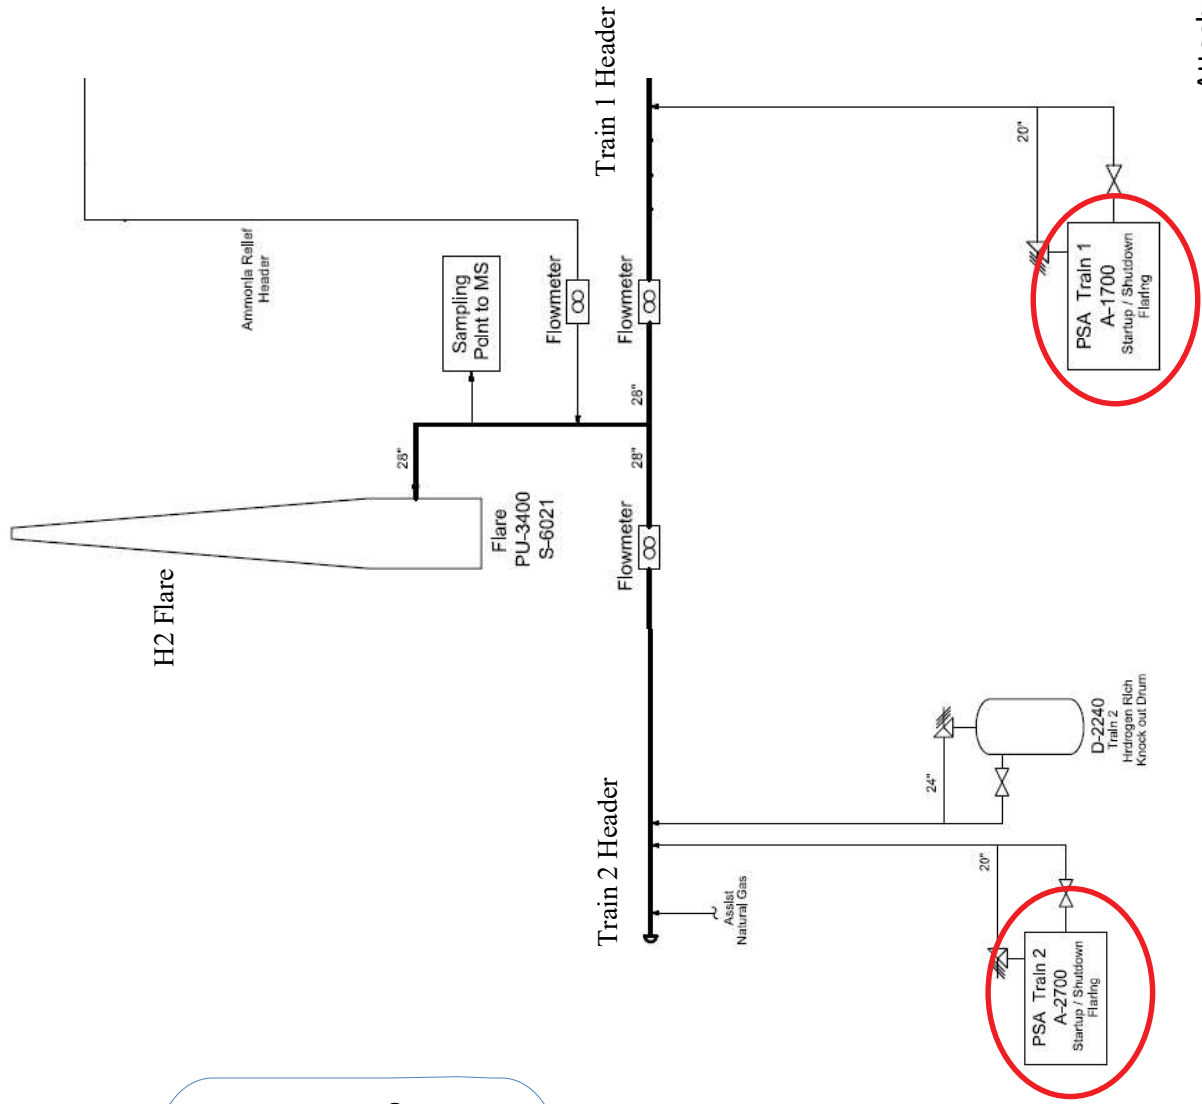
Attachment IIa

Flaring Due to Hydrogen Plant Start-up

Following the power outage on November 2, 2020 Hydrogen Plant start-up began on November 3, 2020 and continued through November 8, 2020. Start-up procedures include routing flows to relief and the Hydrogen Plant flare does not have a water seal or flare gas recovery.
